Report about the prevention and removal of scale with the aid of the “**Scalewatcher**™”

In one of the wastewater treatment plants (North End Sewage Treatment Plant) of Winnipeg, a city with 600,000 inhabitants, the sewage sludge has its water removed in a number of de-watering centrifuges. After that, the water is purified further and then discharged, while the sludge is removed.

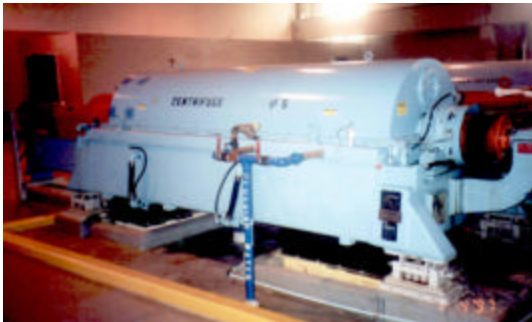
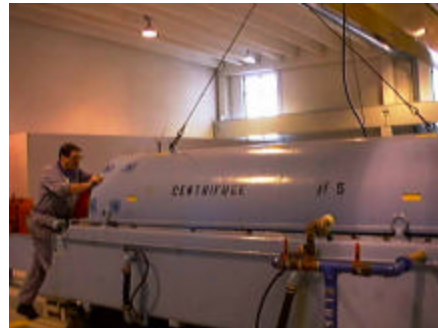
The process

The purification of the sewage sludge occurs in the sludge de-watering centrifuge, in which the centrifugal force separates the sludge from the water. This is possible because sludge is heavier than water.

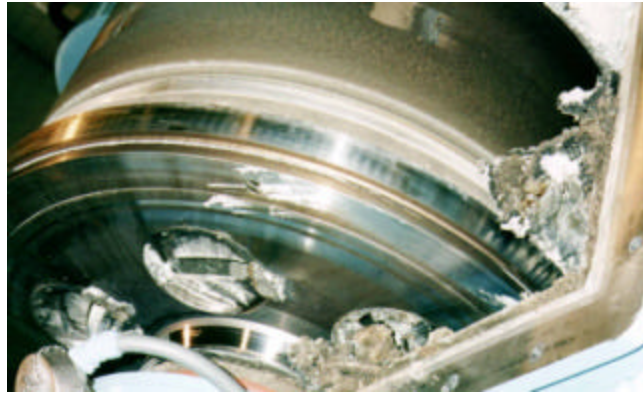
Struvite

Struvite, a hard crystalline deposit that consists of magnesium and ammonium phosphate typically forms and covers the inside of the sludge de-watering centrifuge. These mineral components are found in all sewage slurries containing water. The struvite will form a solid deposit when the sewage sludge is de-watered, as the solubility limit of the magnesium is reduced. The manager of the plant, Mr Jim Main, explained that the struvite problem existed for more than five years. After every 800 hours of operation (approximately two months) the centrifuge had to be stopped and cleaned. This took two people one day with chemicals, hammer and chisel.

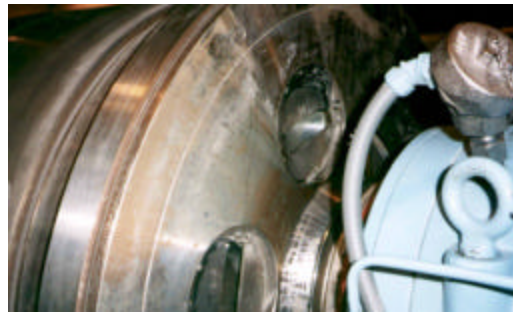
After treatment

On 14 September 1995, the **Scalewatcher**™ test was started. Centrifuge number 5 was chosen for the test. A **Scalewatcher**™ Industrial unit was placed at the centrifuge with an induction cable around the 6" supply mains. When the treated centrifuge was opened during the first inspection on 6 December 1995, it appeared that the wall was only covered with a minimal deposit of softened struvite. On 31 January 1996 the centrifuge was opened and inspected again. The same result could be seen, except that this time the difference was that the wall was even cleaner.

On 1 February 1996, it was decided to run two centrifuges simultaneously, one treated with **Scalewatcher**™ and one untreated. On 15 March 1996, both centrifuges were opened for inspection and both were clean. Another inspection was done on 15 May 1996 with the same results. To be completely sure that the **Scalewatcher**™ had solved the struvite problem, it was decided to switch off the **Scalewatcher**™ and in this way check whether the struvite deposit would return. In the middle of June 1996 it was observed that the struvite deposit had indeed appeared on the wall of the centrifuges again. After that the **Scalewatcher**™ was switched on again and since July 1996 no more deposit of struvite has been observed.
