Report on the Prevention and Removal of scale using “**Scalewatcher**®”

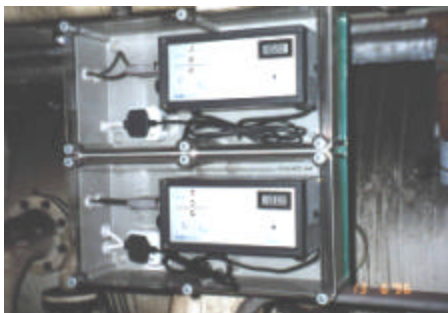
For testing, only two out of 98 pipes at the running out table were chosen. Two **Scalewatcher™** Industrial 3 Systems were chosen and installed on May 30th 1996.

The remaining sections (B) were not treated to get comparable results on the **Scalewatcher™** effect.

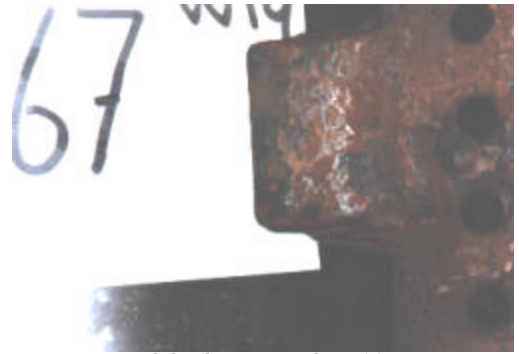
Scaled and in not treated part (B)

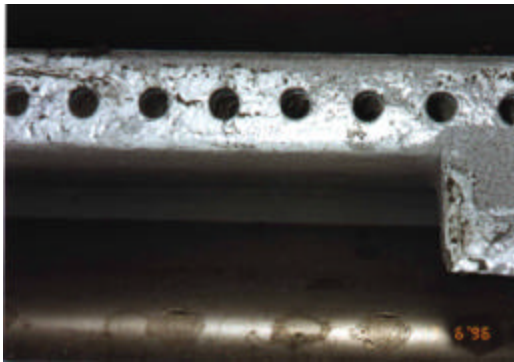
New tray, and in treated part (A)

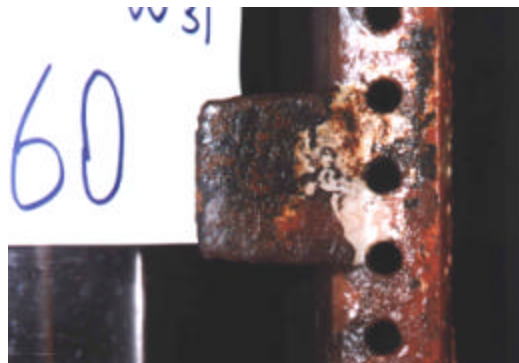
Old scaled tray and in treated part (A)

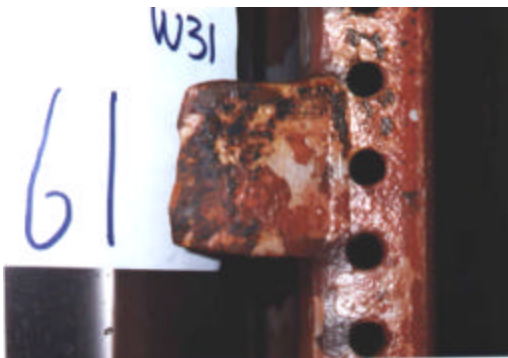
Not treated (B) and cleaned before evaluation

- ◆ Spray nozzles remain open, no deposits on the trays in the treated sections. (Part A)
- ◆ Minor deposits in the indirectly (not) treated sections (Part B)
- ◆ Old deposits are gradually disappearing.
- ◆ After six months, it became clear, that the scale build up in the whole system had decreased remarkably and that the spray nozzles could be cleaned much easier.
- ◆ After twelve months, the drilling team reported that there was no further drilling work on the spray nozzles of the complete running out table to be done.

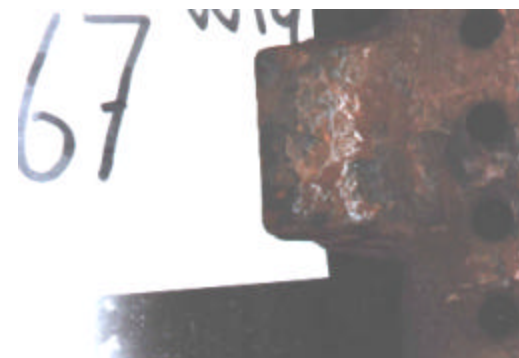
Not treated (B) and scaled before evaluation

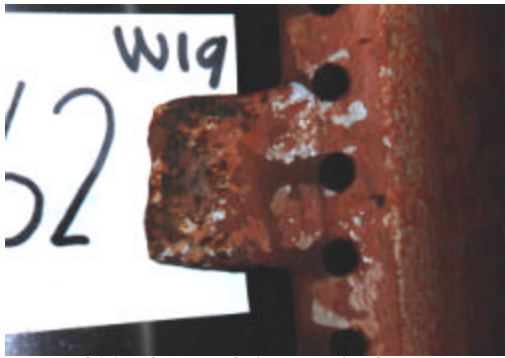
Treated (A) and new tray before start of evaluation

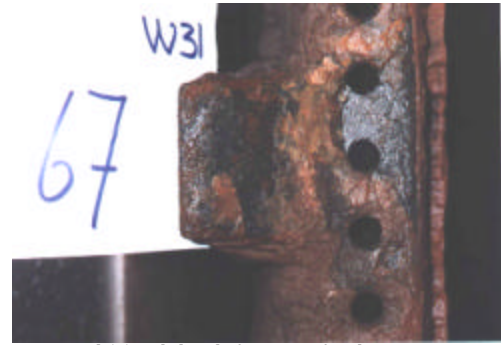
Treated (A) scaled up before start of evaluation
