Newsflash 3, April 1997.
Section: Swimming Pools N° 1

Report of experiments on the prevention and
removal of scale using “**Scalewatcher**TM”

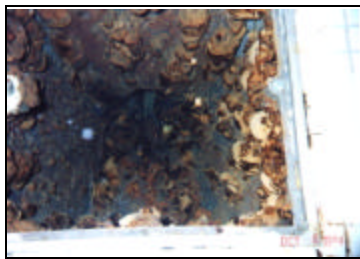
6 Less barnacles. October 6, 1994

Scalewatcher also decreases the other problem, barnacles of iron bacteria. Pictures 3, 6 and 7 show how **Scalewatcher**[™] is removing the barnacles at the outlet in the pool's deep end. These pictures have been taken from the Southern Deep Pool on respectively May 12, 1994, October 6, 1994 and September 9, 1995. The pictures show also a change in color of the barnacles from brown to black. This is a good sign according to Robert Finley.
