Report of experiments on the prevention and  
removal of scale using “**Scalewatcher**<sup>TM</sup>”

**1. The end-user**

A chrysanthemum nursery in the Netherlands owned by Mr Den Brabander. Picture 1.

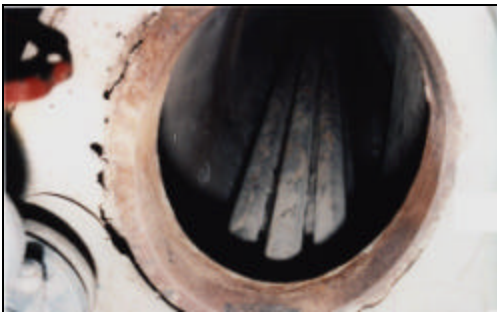
In January 1995, Mr. Den Brabender installed an Industrial **Scalewatcher**<sup>™</sup> unit onto the water feed pipe to the boiler, and regularly inspected the tubes. After twelve months Mr Den Brabender contacted Scalewatcher NL BV for advice, as he was not satisfied with the **Scalewatcher**<sup>™</sup> results. During a subsequent meeting it was decided to create a circulation system. To avoid steam generation in the pipes, the systems pump only operates when the boiler is not used, as steam in the pipes could damage the system. (See drawing 2.) Several weeks after the installation of the circulation system it was noted that the scaled-up fire-tubes were noticeably cleaner. (Picture 3 shows the last inspection in January 1997).

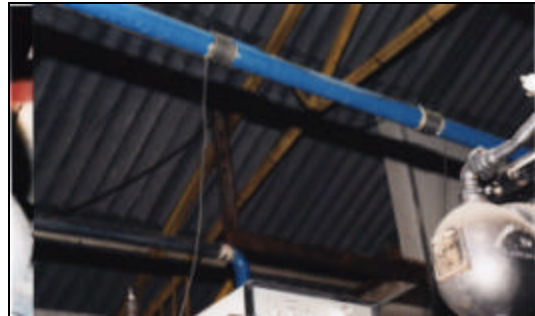
Mr Den Brabander uses a Crone 1,000,000 kcal/h capacity steam boiler at his nursery. Water is drawn from a ditch and heated by a gas fired burner system. Heat is passed via a large primary steel tube and returned through a series of smaller tubes back to the boiler to effect maximum heat recovery. (See drawing 1 and picture 3). The fuel supply and the locking cover of the fire-tubes are clearly shown in picture 2. The nursery's boiler operates for approximately 8 hours a day but only during periods when the ground needs to be steamed to remove bacteria. Picture 4 shows the coil installation.
