Hospital experiments on the prevention and removal of scale in sterilizers using “**Scalewatcher**™”

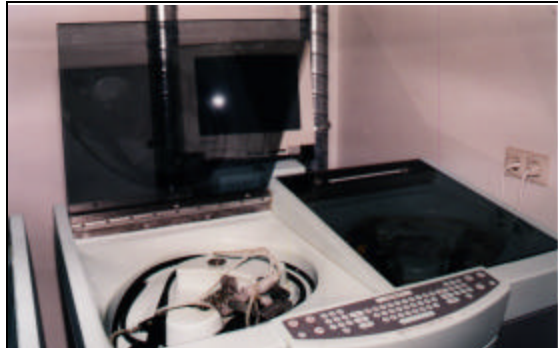
The hospital uses sterilizing equipment (picture 2 and 7) to disinfect its endoscopes. Scale deposits were clogging the small sprinkler openings in the sterilizers. (Pictures 3, 4 and 5)

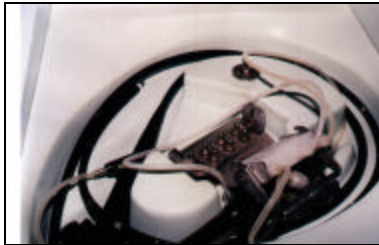
Prior to use, the endoscopes are tested for leaks in the Sterilising Unit (JW2200), manufactured by Dyped in the Netherlands. Picture 3 shows the JW2200 in the enclosure. When it is confirmed that there are no leaks in the equipment, the endoscope is rinsed through with soap and water, which also establishes whether there are any blockages in the equipment. Air is pumped through to remove any traces of soap from the apparatus. The endoscope is then thoroughly cleaned with disinfectant and is rinsed twice. The tank is emptied and all tubes are cleared. A computerised system controls the process. The disinfecting unit is self-regulating and in addition to controlling both the water and disinfectant it is also capable of automatic thermal disinfection.

The element inside the sterilizer continually scaled-up, necessitating regular maintenance to keep the machine fully operational. Scaling was occurring in the boilers being used to heat water for the thermal self-rinsing as well as the washing equipment. This caused choking up of the sprinkler openings and poor water temperature control. The unit was therefore not working effectively, which not only lead to increasing energy costs but could result in the endoscopes not being fully sterilized. Picture 3 shows a rinsing unit with an endoscope around it.

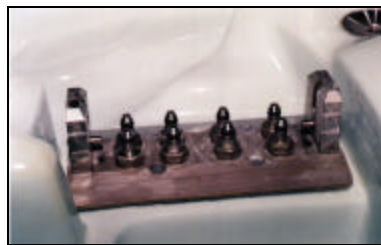
4

An inspection two months after the **Scalewatcher**[™] system was installed, showed the new unit (B) was completely scale free whilst in the older unit (A) (picture 4) far less scale was visible. Unit C (picture 5) showed an increasing scale build-up as usual. An inspection six months later showed even a better result and it was concluded that the experiment was a success.

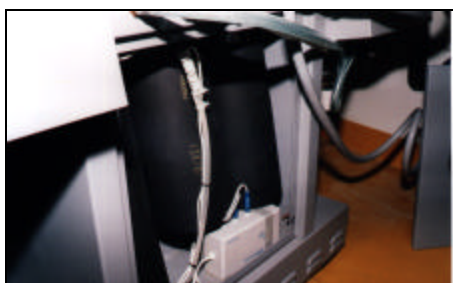
6

The **Scalewatcher**[™] Commercial was attached to 15 mm (0.6 inch) diameter tubes. (Picture 6)
