Newsflash7, May 1997.

Section: Food. Application: Heat exchangers no 2.

Report of experiments on the prevention and removal of
scale by using "**Scalewatcher**TM".

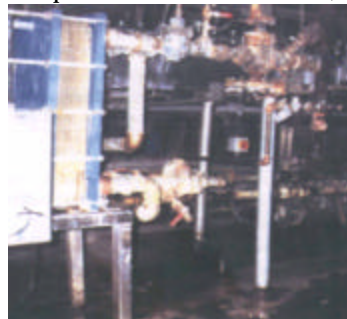
2

The heat exchanger is used on the glass bottle rinsers to heat up the circulating water which is sprayed on the outside of the bottles to prevent thermal shock when the bottles are filled with hot pasteurised juice which can reach temperatures of 203 °F (Picture 2). Failure to preheat the bottles could cause them to shatter when filled with the hot juice.

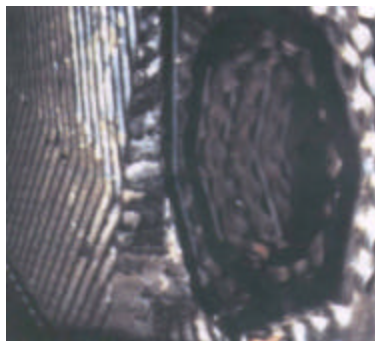
3

In September, during a planned shutdown, and just 2 weeks after installation, the circulating pump was pulled out and the inside of the volute and impeller were examined for scale build up. Normally, excessive scale resulted in Sweet Ripe replacing the pump every 18 months. Much to their surprise, the inspection team found the pump to be relatively clean from scale, and the small amount of scale present was soft and easily removed with a brush. It was also found that the pump and the inlet pipe were totally free of any scale build-up. The plates of the heat exchanger were also checked and were found to be fairly clean. (Picture 3) Scale remaining was soft and could easily be removed by hand.

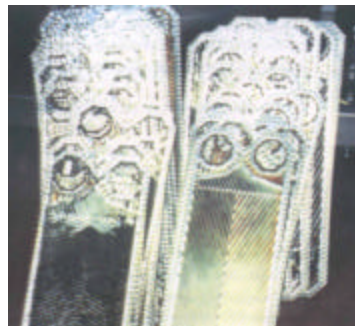
4

On November 1st when the heat exchanger plates were pulled apart, so that the gasket could be replaced, it was noted that 100% more of the previous existing scale build-up had been dissolved (Picture 4) and passed through the system to drain. Further inspections on December 1st showed the plates to be completely scale free and were in fact cleaner than the steam side of the heat exchanger.
